PRE FINAL/FINAL REMEDIAL DESIGN

Eagle Zinc OU1 Site

Hillsboro, Illinois

January 2011

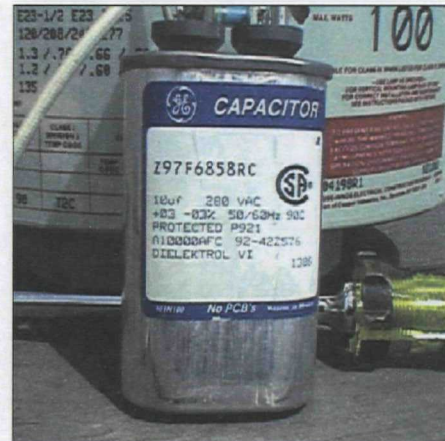
REMOVE AND EXAMINE THE SMALL CAPACITOR.
NOTE: "NO PCB'S" ON LABEL.

If managed separate from ballasts, small capacitors (even non-PCB liquid-filled small capacitors) will be contained separately, and not put in general trash or scrap metal receptacles. Leaking capacitors will be placed in a container marked PCB-containing waste.

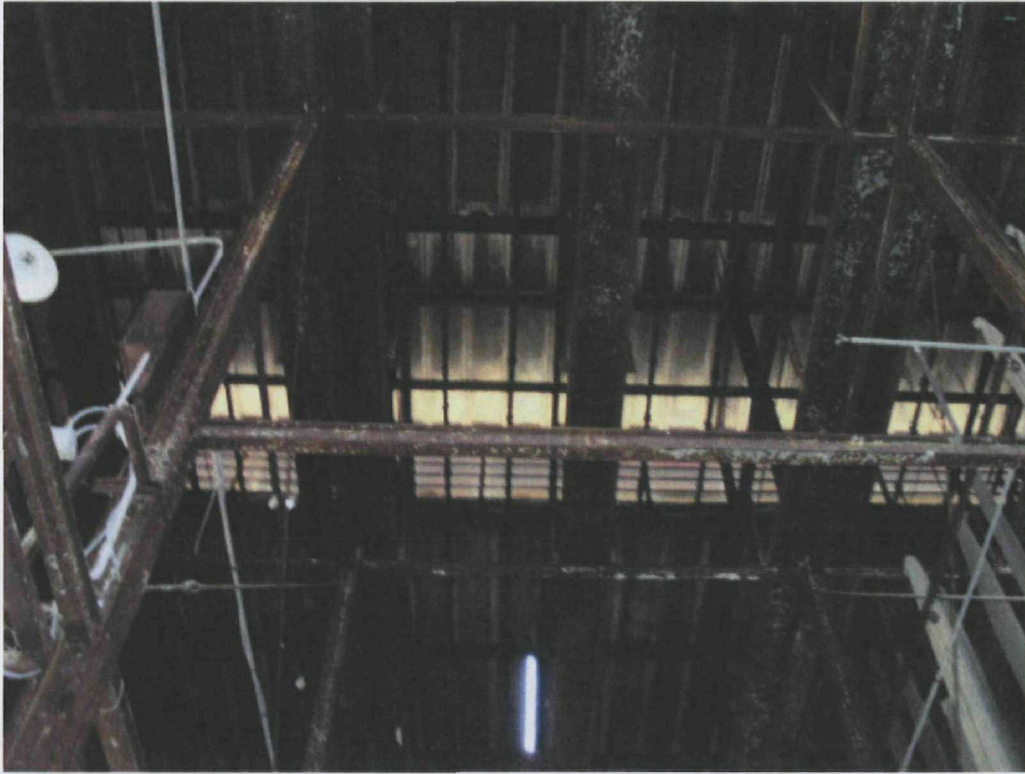
Photo 11: Structural steel within Building D

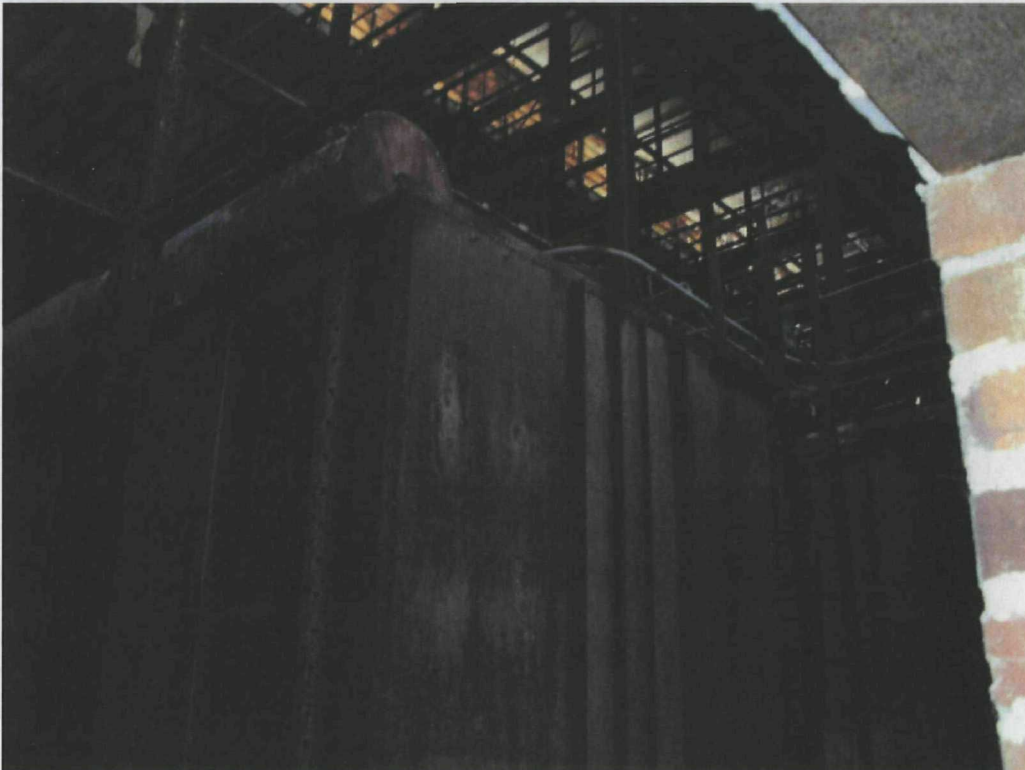
Photo 12: Equipment within Building D

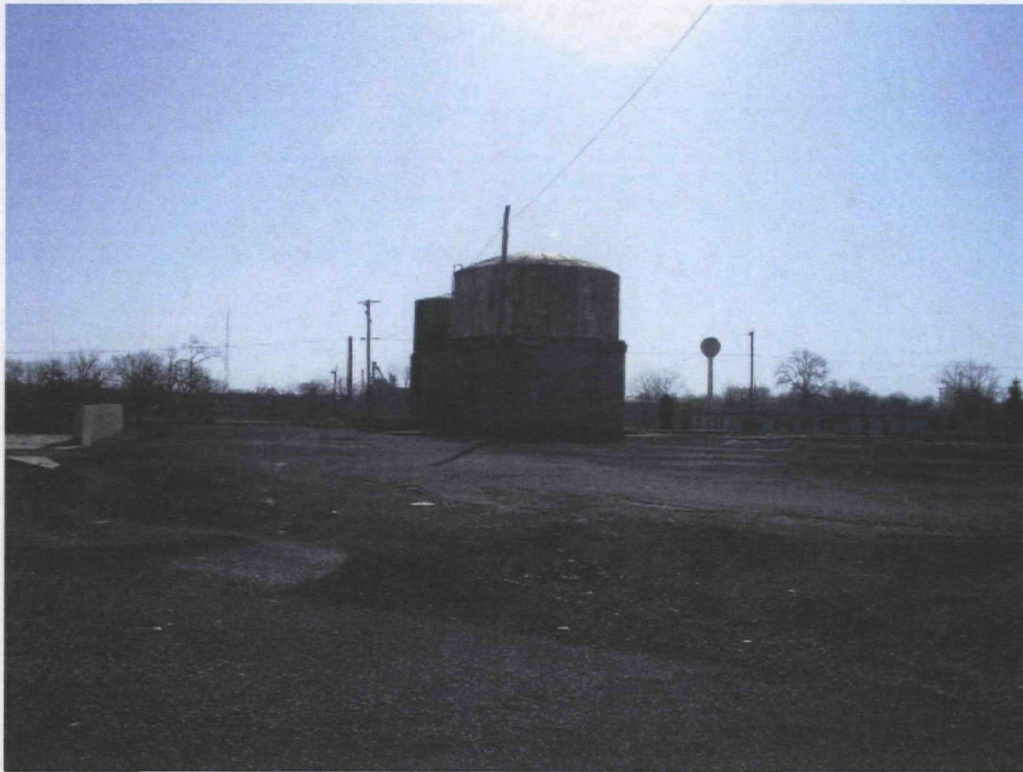
Photo 43: Two ASTs on concrete foundations.

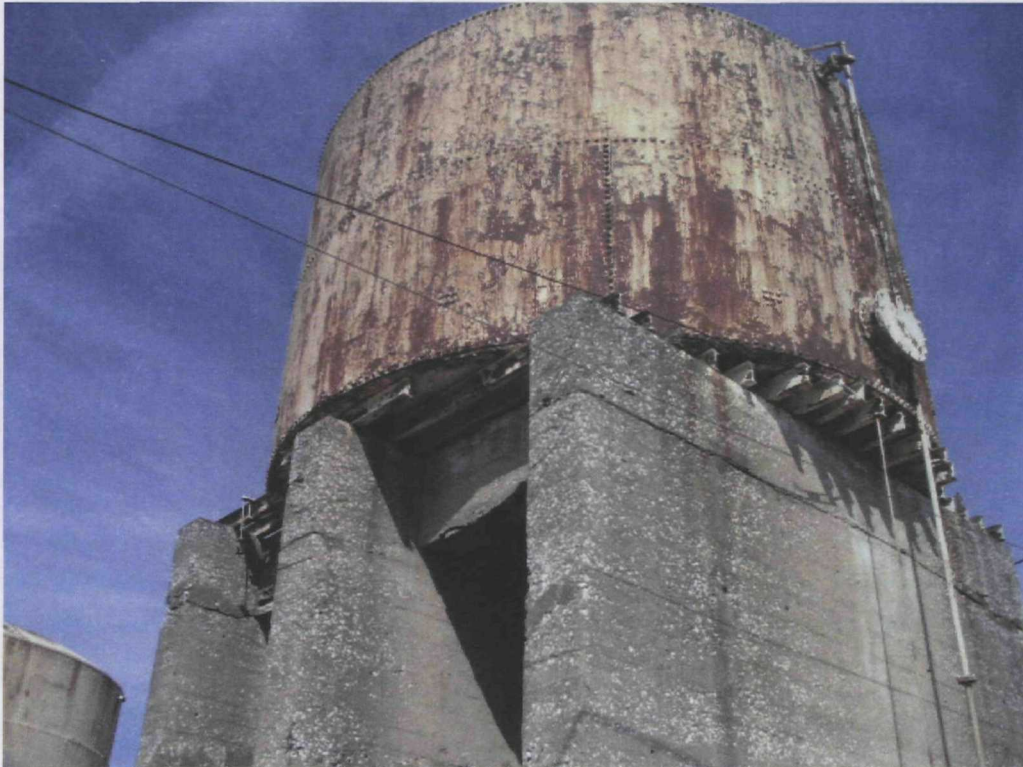
Photo 44: Close-up of one AST on concrete foundation.

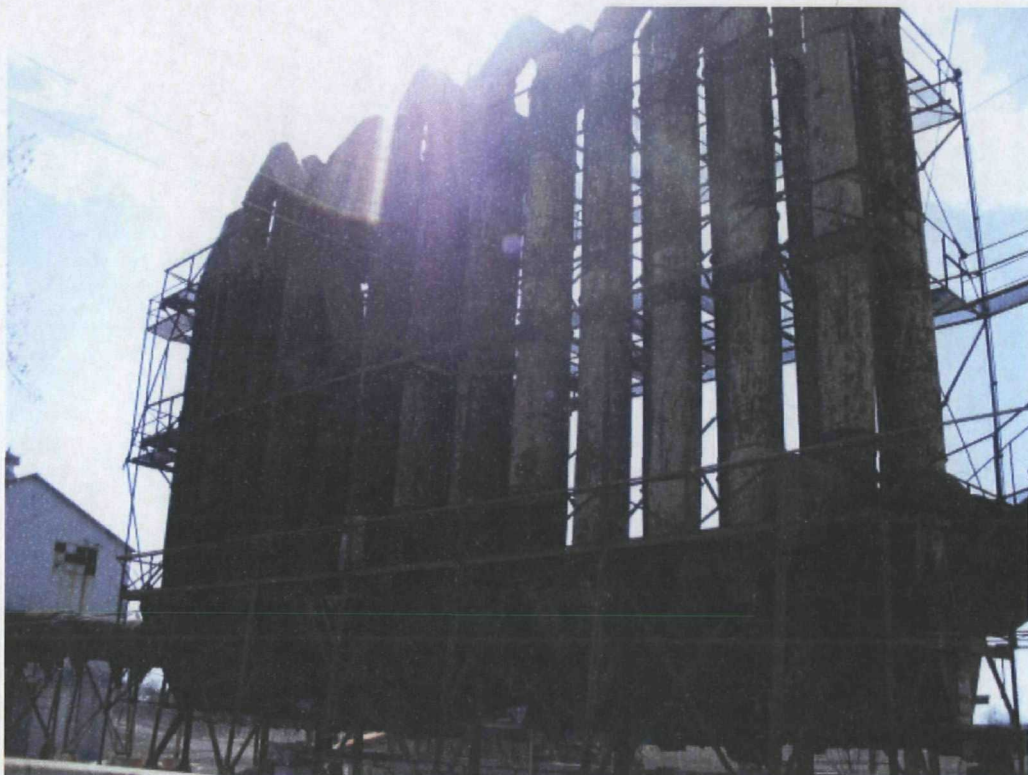
Photo 45: Cooling Tower

Name	Location	Material of Construction
Cooling Tower	Between Buildings I and J	Steel
Site Duct Conveyor	Between Buildings E and F	Steel

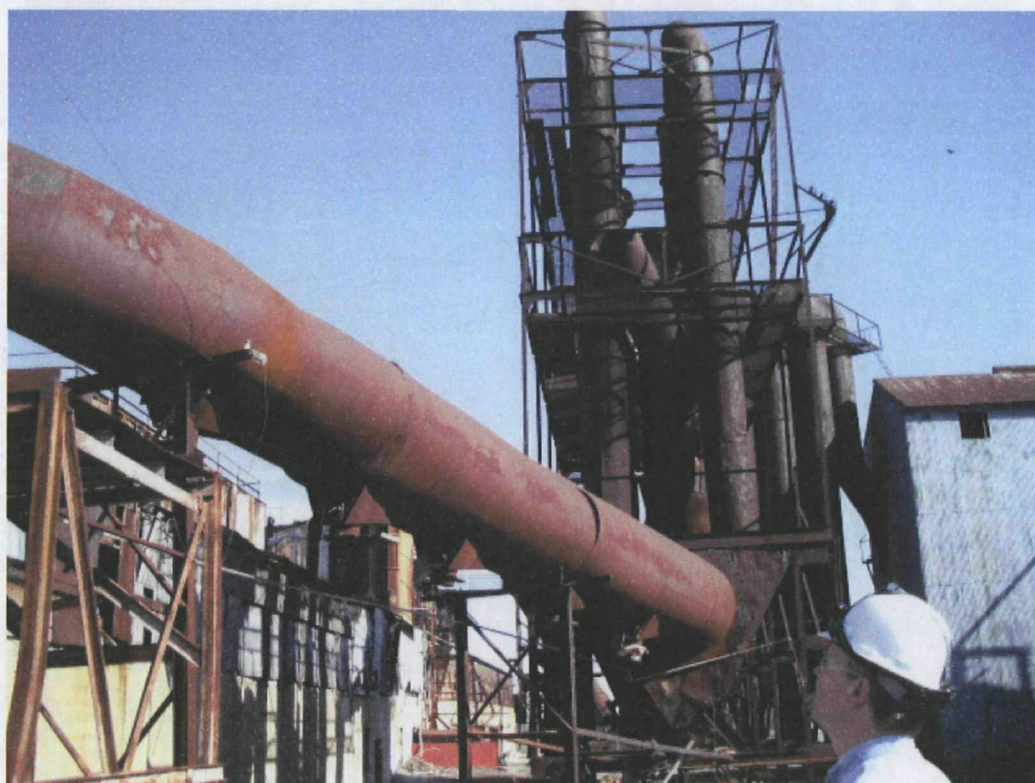
Photo 46: Site Duct Conveyor between Main Rotary Kiln Building and Fan Buildings

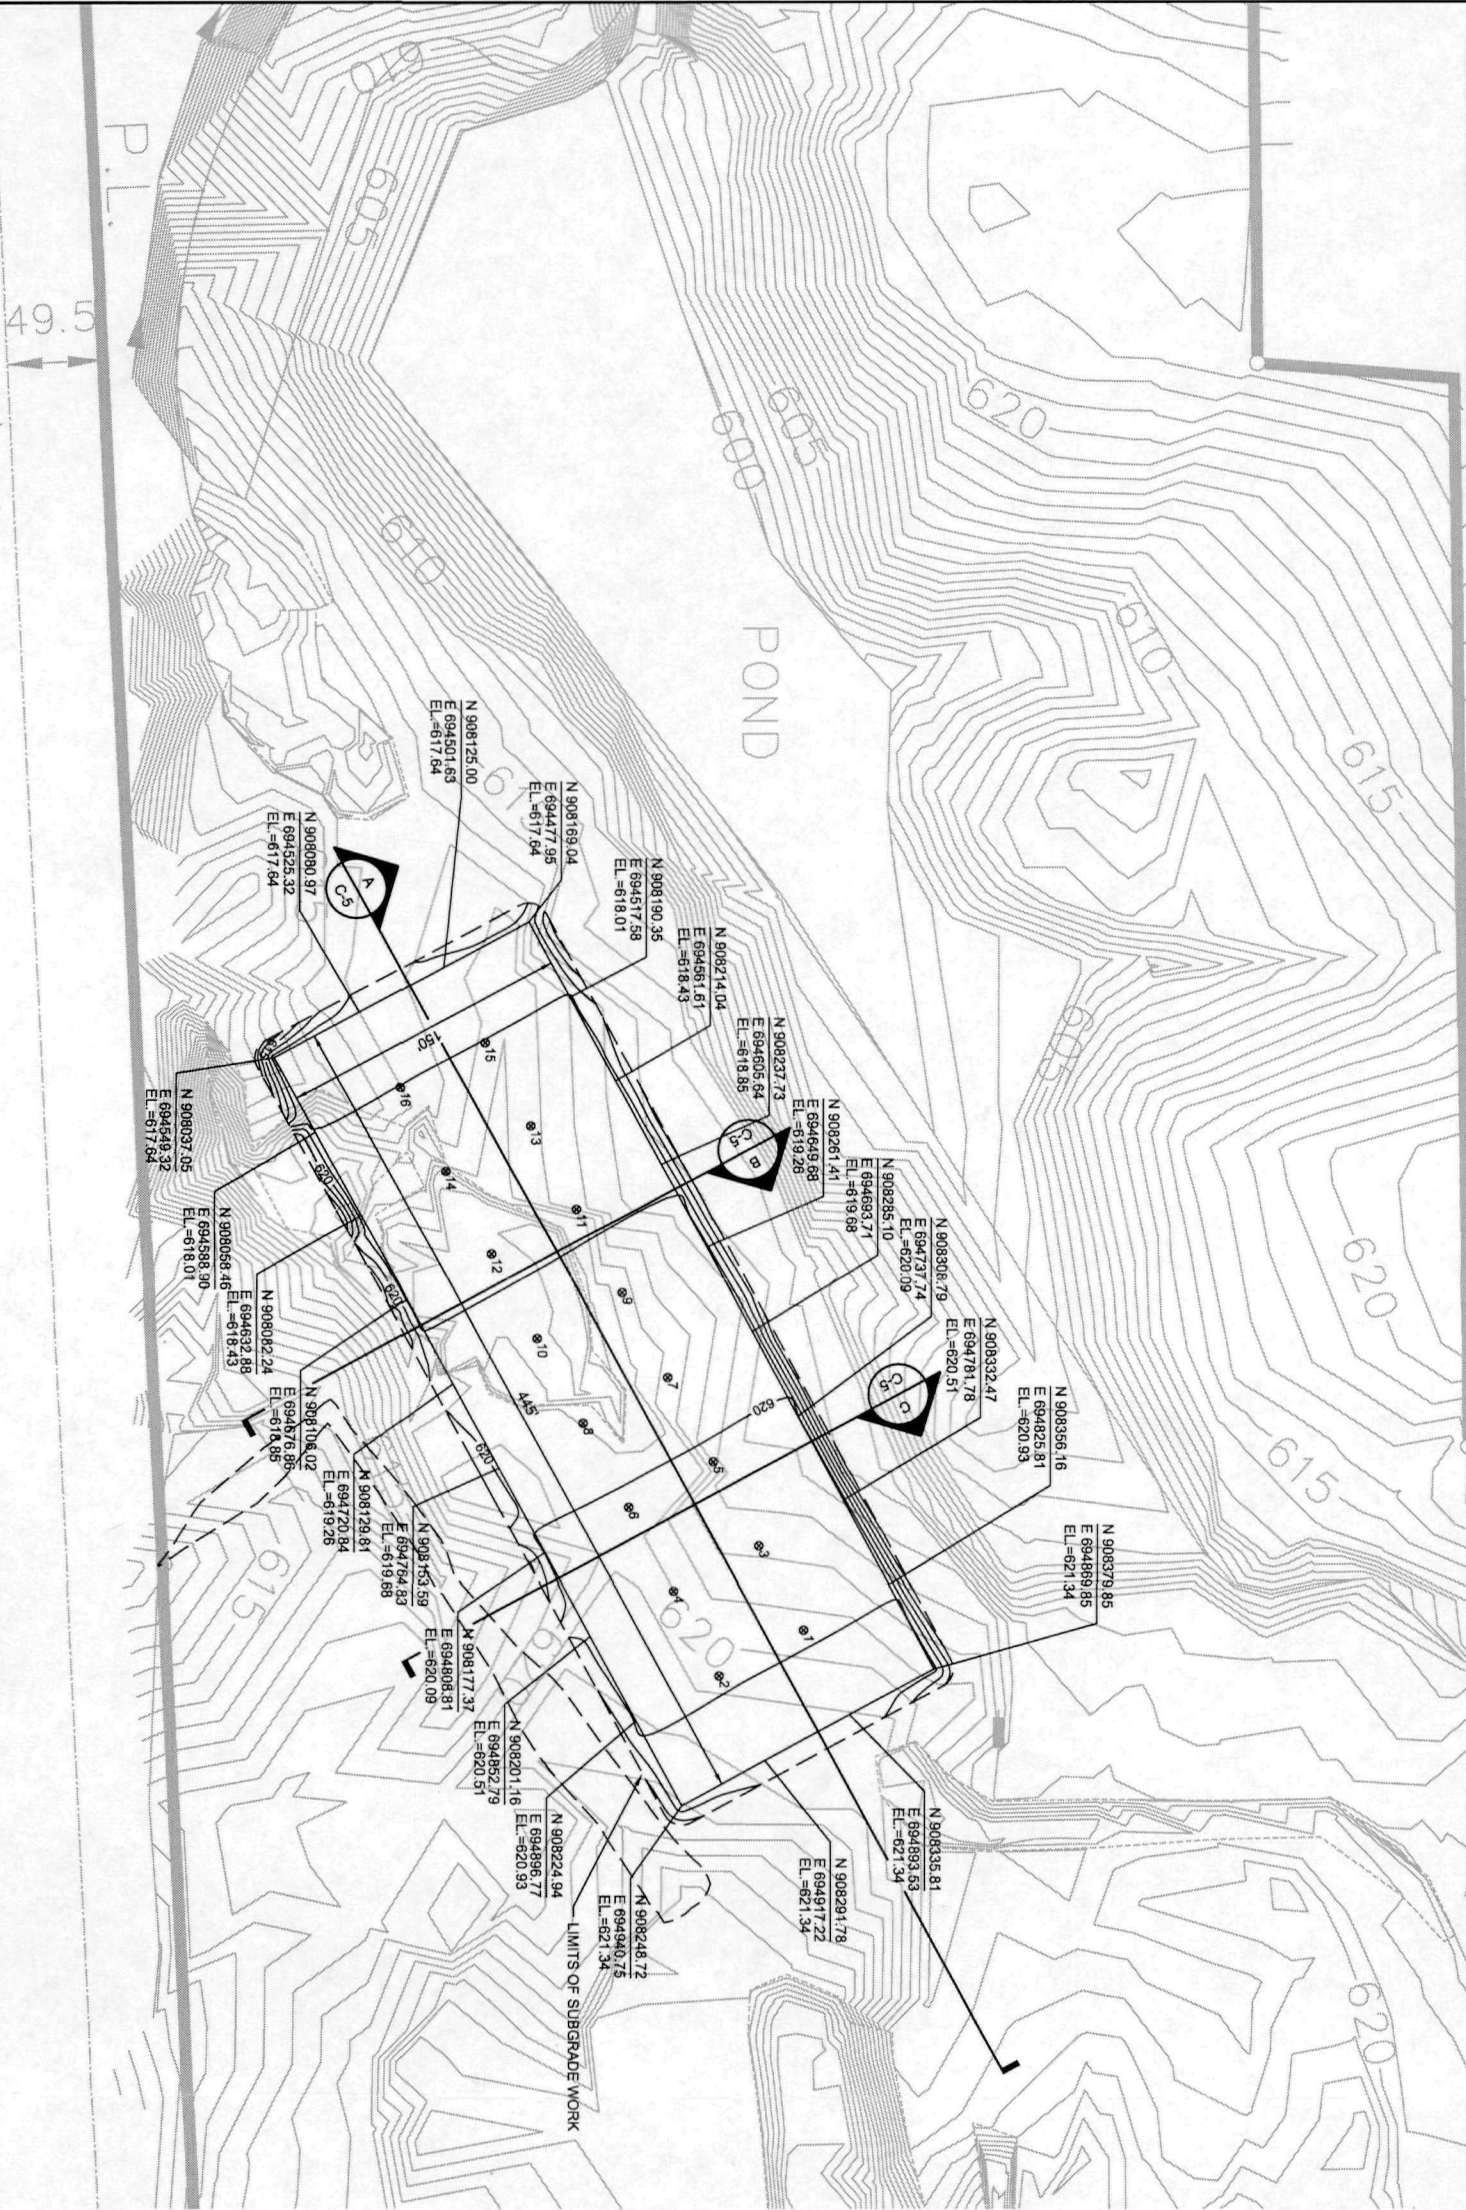
CH2MHILL	CIVIL	EAGLE ZINC REMEDIAL DESIGN HILLSBORO, ILLINOIS US ENVIRONMENTAL PROTECTION AGENCY
SUBGRADE PLAN

SUBGRADE PREPERATION
** Total Cut = 2595 Cubic Yards **
** Total Fill = 2336 Cubic Yards **
** Area = 8750 Sq Yards **
** Balance = 259 Cubic Yards **
NOTE: QUANTITIES FOR SUBGRADE PREPERATION WERE ESTIMATED FOR COST ESTIMATING PURPOSES.
